Contract #: 04-0120F4Cty: SF/ALA Rte: 80 PM: 13.2/13.9File #: 13.28**WELDING INSPECTION REPORT****Resident Engineer:**Pursell, Gary**Address:** 333 Burma Road**City:** Oakland, CA 94607**Report No:** WIR-008990**Date Inspected:** 16-Sep-2009**Project Name:** SAS Superstructure**OSM Arrival Time:** 1900**Prime Contractor:** American Bridge/Fluor Enterprises, a JV**OSM Departure Time:** 330**Contractor:** Oregon Iron Works Clackamas, Or.**Location:** Clackamas, OR**CWI Name:** Steve Barnett, Jon Nickolich**CWI Present:** Yes No**Inspected CWI report:** Yes No N/A**Rod Oven in Use:** Yes No N/A**Electrode to specification:** Yes No N/A**Weld Procedures Followed:** Yes No N/A**Qualified Welders:** Yes No N/A**Verified Joint Fit-up:** Yes No N/A**Approved Drawings:** Yes No N/A**Approved WPS:** Yes No N/A**Delayed / Cancelled:** Yes No N/A**Bridge No:** 34-0006**Component:** Hinge-K Components**Summary of Items Observed:**

OIW Fabrication Shop-Bay 3**Hinge-K Pipe Beam Base Assembly 102A-2:**

Hinge-K Pipe Beam Fuse Assembly 120A-5:

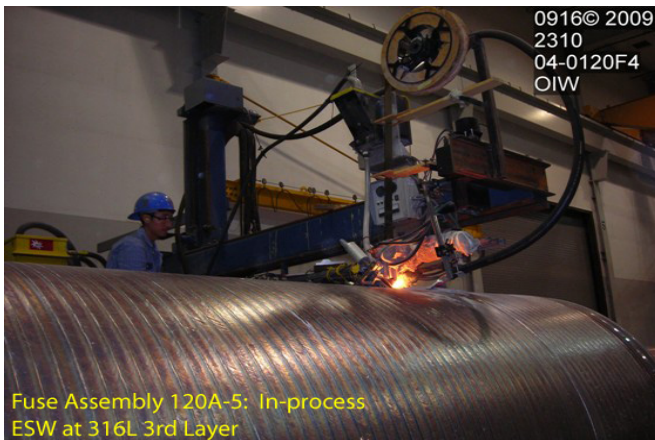
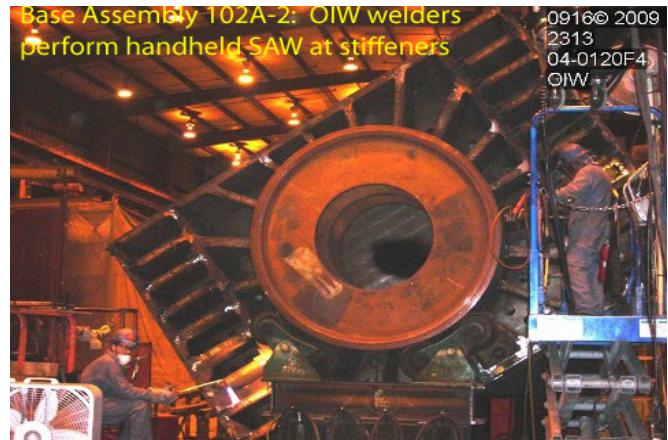
The QA Inspector intermittently monitored OIW welders Yuriy Bannikov (WID B61) and Phuong Huynh (WID H4) on swing shift and Jose Camera (WID C33) on graveyard shift during in progress Submerged Arc Welding (SAW) at weld joints W1-80, W1-76, W1-72, W1-68, W1-64, W1-39, W1-35, W1-31, W1-27, W1-23 and W1-19.

The referenced connections are fillet welds joining various stiffeners to a107 and b106 gussets. The QA Inspector observed as OIW QC Inspector Steve Barnett performed Magnetic particle Testing (MT) and Visual Inspection (VT) of completed root pass at weld joints referenced above. The testing performed was informational MT at root pass of these fillet joints at the behest of OIW QC management. Mr. Barnett stated that he had located no rejectable indications. The QA Inspector intermittently observed as welders B61, H4 & C33 deposited SAW passes in the horizontal (2F) position in accordance with approved welding procedure 4020. The QA Inspector noted the OIW welders were maintaining continuous preheat utilizing a torch. Referenced connections W1-80, W1-76, W1-72, W1-68, W1-64, W1-39, W1-35 and W1-31 were completed during the swing shift and W1-27, W1-23 and W1-19 were completed during graveyard shift. The QA Inspector observed OIW QC Inspectors Steve Barnett and Jon Nikolich regularly monitoring and recording the in process SAW parameters during swing and

The QA Inspector intermittently observed OIW qualified welder Bounheune Savanh (WID S74) during in-process welding of Soudotape 316L stainless steel overlay to hinge k pipe beam fuse sub-assembly 120A-5. The weld joint is identified as 316L 3rd Layer. Mr. Savanh was observed welding in the flat position utilizing automatic electro slag welding (ESW) overlay process with a .5mm x 60mm Soudotape 316L stainless electrode, filler metal brand Soudotape class EQ316L automatic. An OIW helper was observed assisting welder S74 during ESW activity. The QA Inspector observed OIW QC Inspector Steve Barnett regularly monitoring and recording the in process ESW parameters. The QA Inspector also intermittently observed in process welding parameters and determined that the ESW parameters (1200 amps, 25.5 volts, 267mm/min travel speed) and minimum preheat temperature of 70° F appeared to be in general compliance with the contract requirements and approved OIW Welding Procedure Specification (WPS) 7003.
